CASE STUDY | SCREW WASHING PRESS

Wastewater Treatment Plant: Le Canet en Roussillon, FRANCE

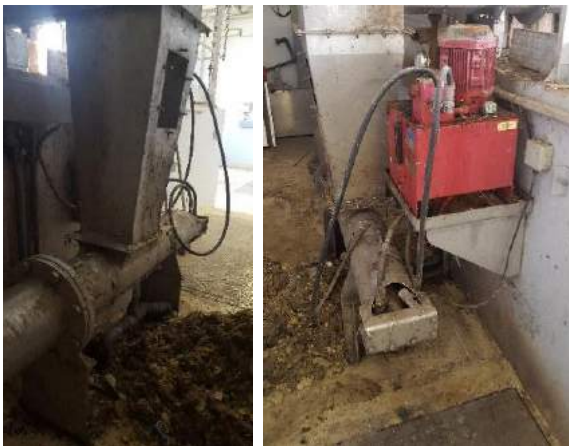
BEFORE: Piston compactor

A piston compactor received waste coming from two coarse screens. During the screenings discharge into the compactor, a vault effect caused a clogging in the hopper.

Waste discharge on the piston

Vault effect inside the hopper

Equipment shutdown

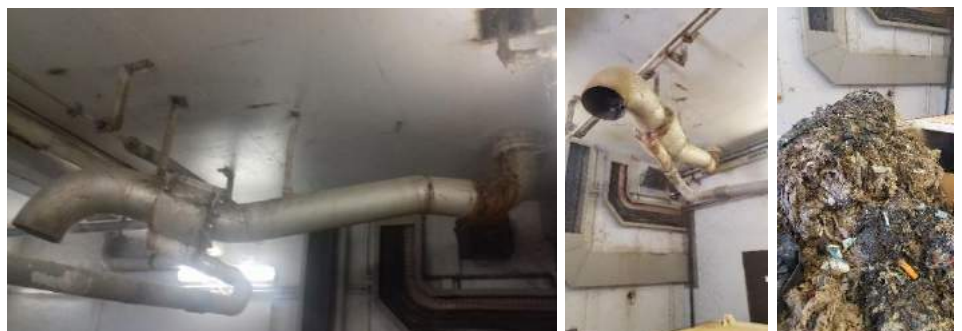
Specific waste discharge piping outlet

- ➔ Length 5 meters
- ➔ Two 90° turns
- ➔ Diameter variation

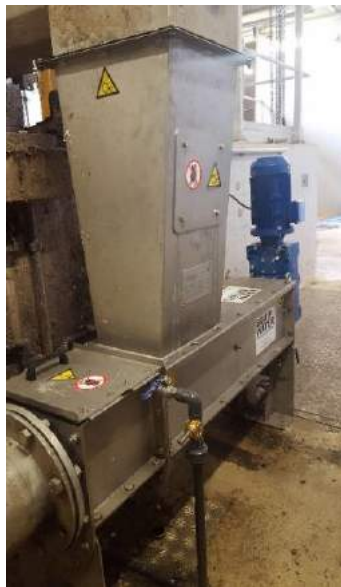
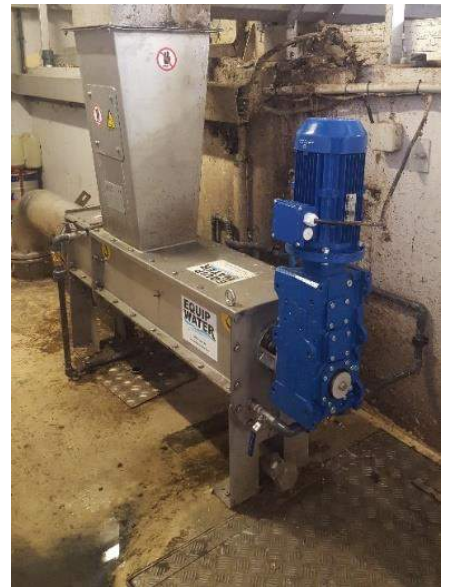
AFTER: Screw compactor **EQUIP PRESS 200**

A customized EQUIP PRESS screw compactor suitable for the upstream conveyor and the existing piping.

- Screw compactor
- Waste discharge on the spiral
- Custom hopper
- Spiral diameter ø200 (8")

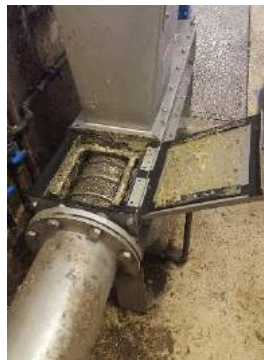
OPTIONS

- Spray bar
- Washing zone
- Shafted screw
